**TEST REPORT Nr. 6727/10**

Requested by:	INDUSTRIE PICA S.p.A.  Strada Montefeltro, 83  61122 PESARO
On (date):	21/09/10
For the sample marked:	"TEGOLA PORTOGHESE ROSSA IN LATERIZIO - Produttore INDUSTRIE PICA - Stabilimento di Asti".

**EN 539-2 (6/2006) - Clay roofing tiles for discontinuous laying**  
**Determination of physical characteristics – Part 2: Test for frost resistance**

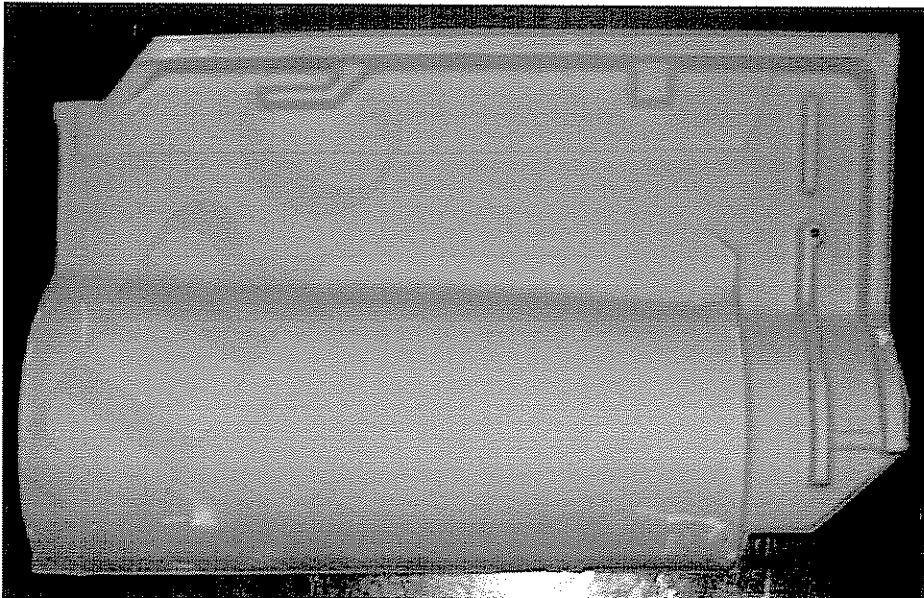
photo 1

<b>DESCRIPTION OF THE SAMPLE:</b> Clay roofing tiles, 41.5 x 25.5 cm marked "TEGOLA PORTOGHESE ROSSA IN LATERIZIO - Produttore INDUSTRIE PICA - Stabilimento di Asti", see photo 1.	
<b>MANUFACTURER:</b> -----	
<b>SAMPLING DETAILS:</b> - Where: ----- - Date: ----- - By whom: CUSTOMER - How (methods): -----	
<b>DATE OF RECEIVAL IN LABORATORY:</b> 17/09/2010
